# How to Spot a Fake:

## Philips 85122+ D2S Bulb

Brought to you by The Retrofit Source Inc.

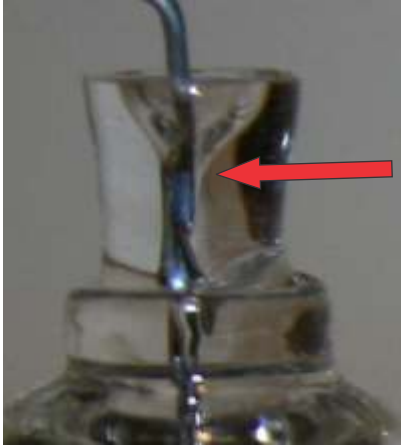
**Real:** Very good formation of the glass, small indentation in the center, return wire weld is encased in glass, bulb is sealed far from the glass body.

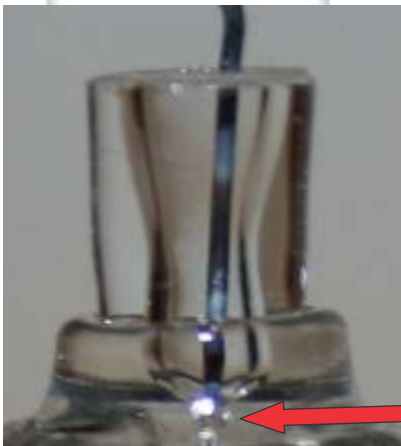
**Fake 1:** Much taller than the real Philips, return wire weld is not encased in the glass, bulb is sealed much closer to center of bulb body.

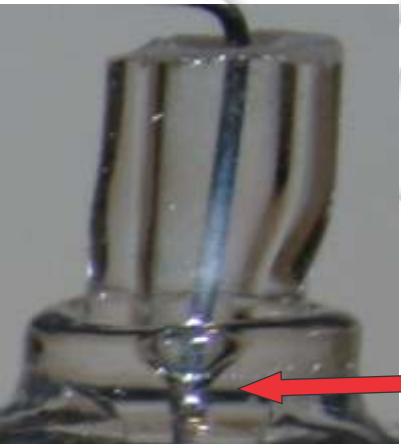
**Fake 2:** Sloppy formation of glass (slightly tilted and not straight), Return wire weld not enclosed in glass, bulb is sealed much closer to center of bulb body.

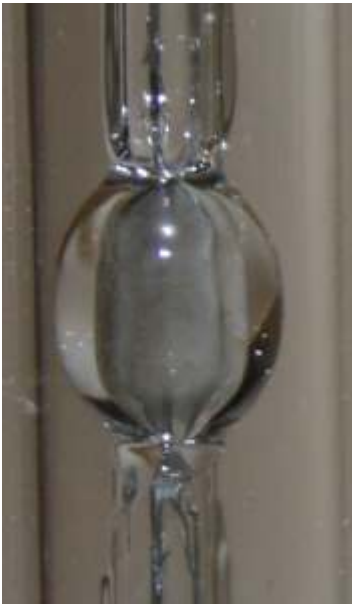
**Real:** Nicely formed oval shape capsule, good size that is symmetrical in shape, thicker glass encasing diodes, white or slightly gray colored salts.

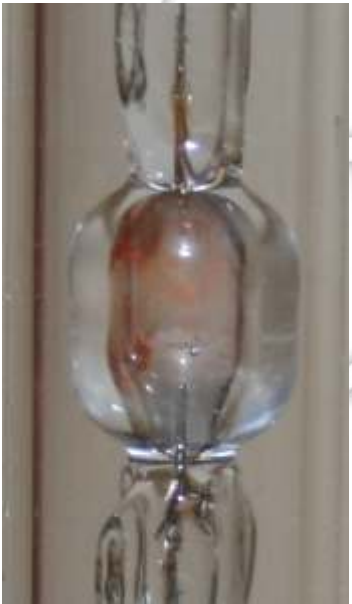
**Fake 1:** Poorly formed capsule more square in shape, poorly formed glass that encases diodes very uneven, salts are red in color which is not correct for an 85122+.

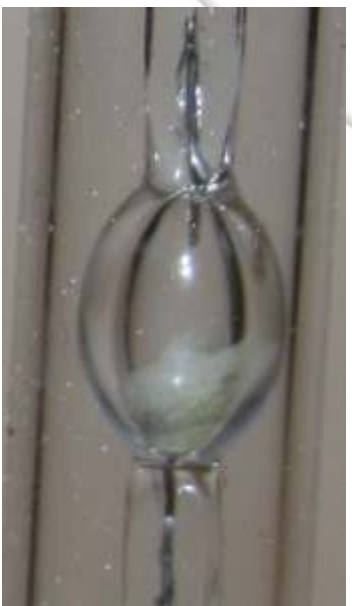
**Fake 2:** Oval shaped capsule that is very small and not symmetrical in shape, thin glass encasing diodes, salts are white and slightly yellow.

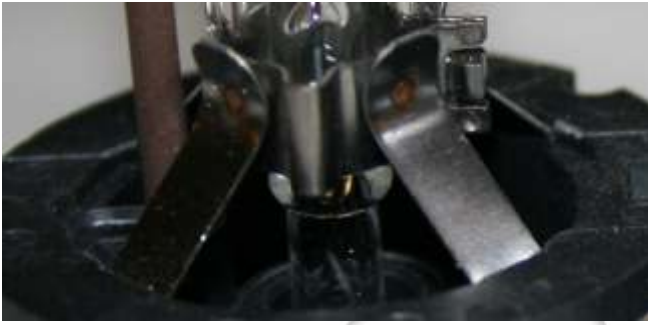
**Real:** Larger perfectly symmetrical rivets, nicely tapered and formed lower glass tube, Zig-Zag Pattern of lower power wire within lower glass.

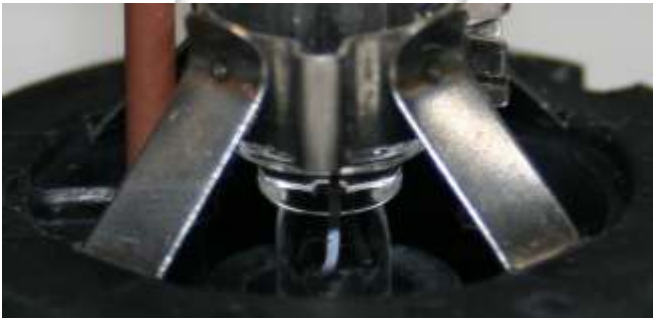
**Fake 1:** Smaller rivets, the glass is nicely formed but the tube is overly large, lower power wire is mostly straight.

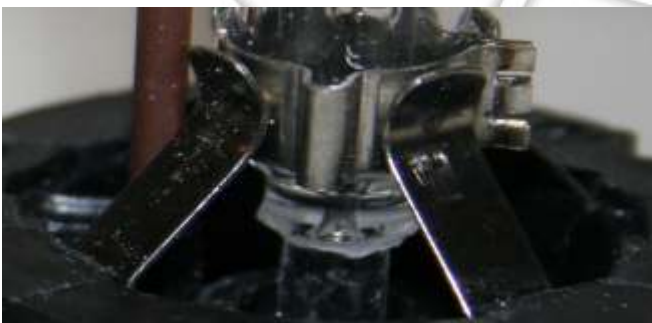
**Fake 2:** Rivets are almost not noticeable, poorly formed lower glass tube, has Zig-Zag lower power wire.

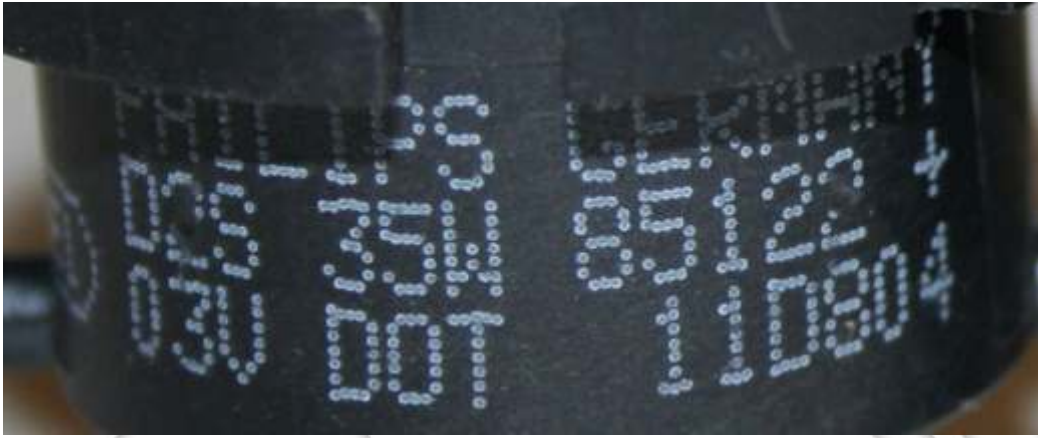
**Real:** Typing is made up of individual dots, matte white in color, spacing between words, letters and lines is all uniform.

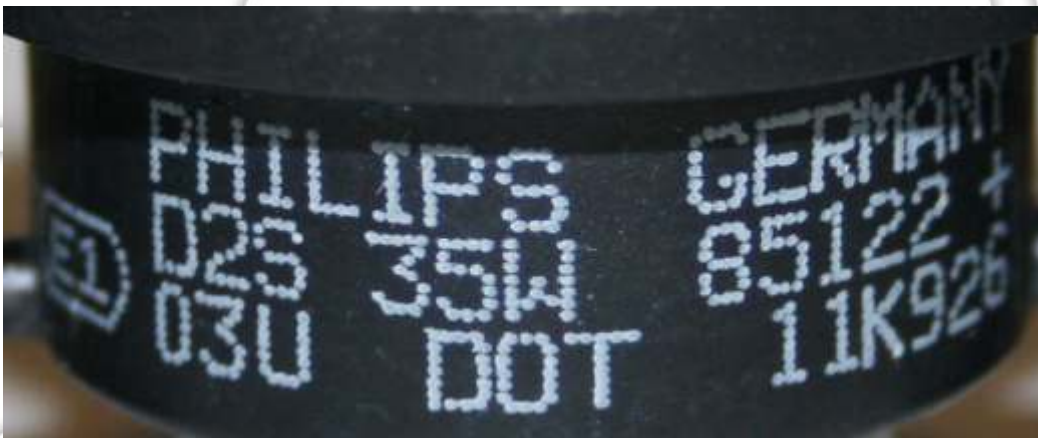
**Fake 1:** Typing still using individual dots but dots blend together, much too bright white, spacing is not uniform between letters and much too narrow between lines.

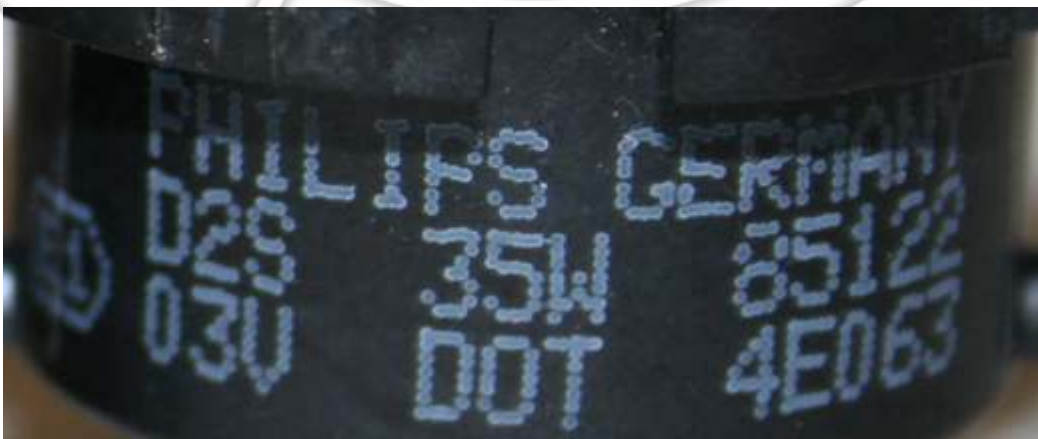
**Fake 2:** Typing still using dots but blend together badly, much too dull white, spacing is not uniform and letters are not formed correctly

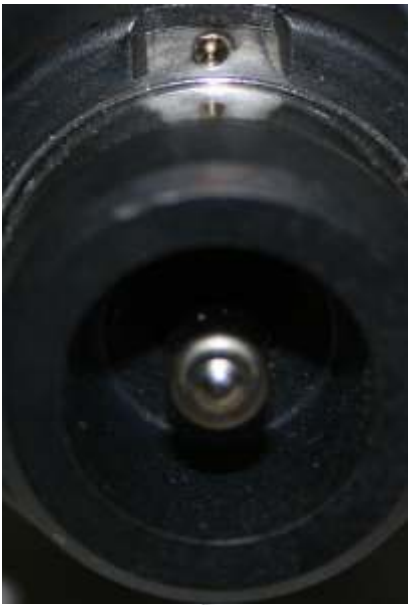
**Real:** Small solder at the top is perfectly centered and nicely formed, protrusion on the center metal post fill most of the surface and nicely formed

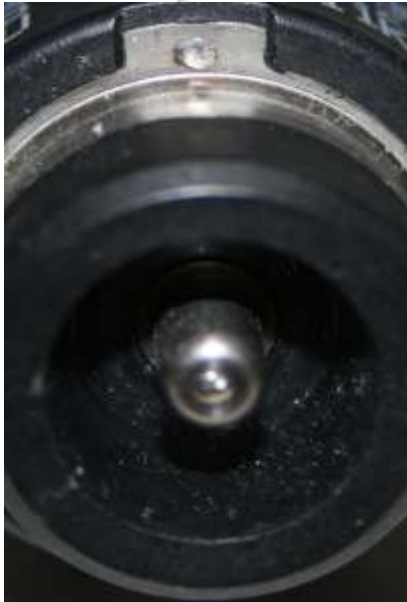
**Fake 1:** Small solder at the top is not centered and poorly formed, protrusion on the center metal post is poor formed and much too small.

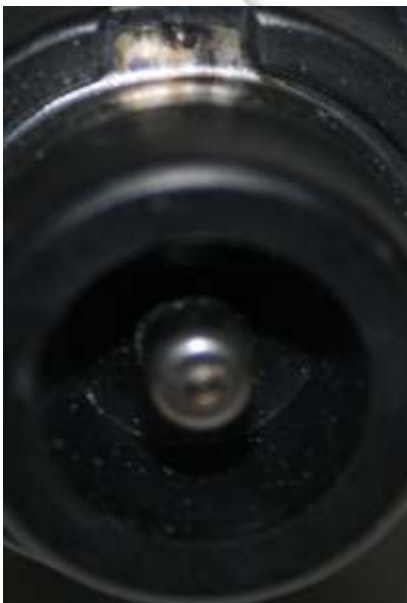
**Fake 2:** Small solder at the top is almost non-existent, protrusion on the center metal post is poorly formed and very small.
